A BRIEF REPORT ON

"ALKALI - AGGREGATE REACTIONS IN NEW YORK STATE"

Tom Pratuch
Ass't Civil Engineer
Region 4, NYSDOT

(Presented in Albany, New York on February 2, 1977)

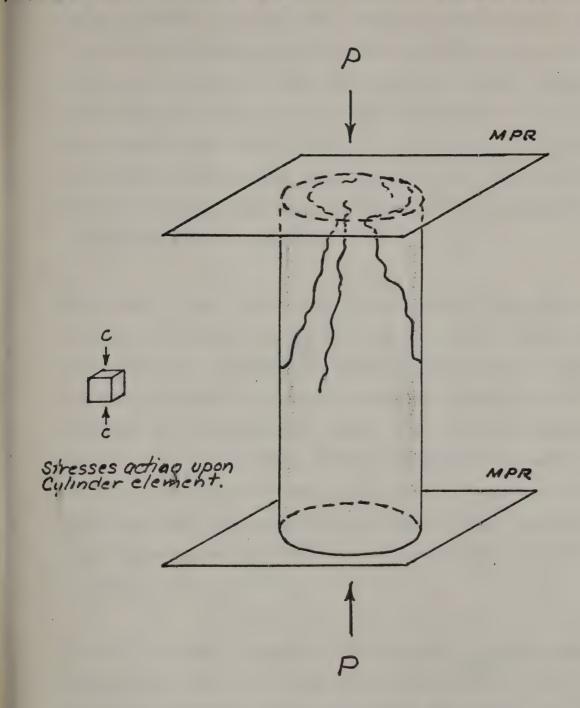
The heavy circumferential closely spaced steel mesh reinforcing at the exterior surface of the pipe restricts the deformation of the expanding elements along the individual loops of reinforcing. Hence, we find the cracks tend to occur between

the individual wire strands where the expanding elements are less restrained. The concrete fails in shear at first, in the same manner concrete test cylinders fail when loaded beyond their maximum compressive strength. This spall type failure is often found in structural units in the field that exhibit distress features characteristic of alkali-aggregate reactivity. For example, our round reinforced concrete columns in the hochester region are often fractured in this fashion. In all three cases mentioned, the first cracks visible to the naked fairly eye are oriented perpendicular to the major planes of restraint.

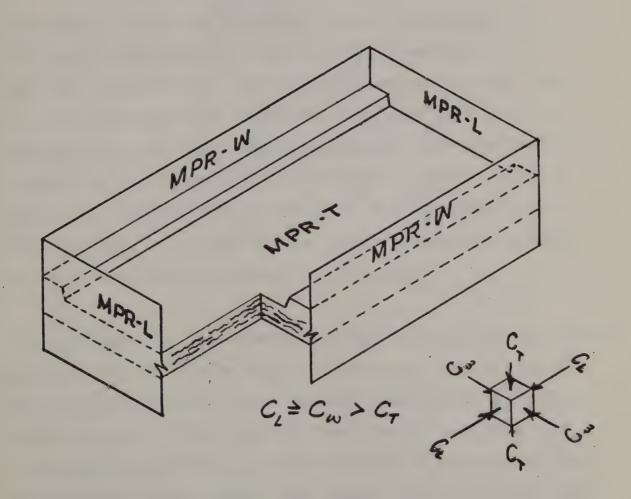
Major Planes of Restraint Operating On A Simple Span Two-Way Reinforced Concrete Bridge Deck

Finally, through the use of the concept of "Major Planes of Restraint", I believe I can explain the delamination of our reinforced concrete decks, that to my knowledge, has never been satisfactorily explained on any other basis.

Delamination Effect

Under these conditions the major plane of restraint will will exist at the ends of the deck. The secondary major plane of restraint will exist at the sides of the deck. And the very minor plane of restraint will exist at the top and bottom of the deck. Any element undergoing expansion in the interior of the concrete deck will find it easier to deform the across the thickness "T" of the slab. Since concrete will fail in shear, the deck will tend to delaminate parallel to the top and bottom surfaces of the deck.
